# Strength of Rapid Repair of Grouted Sand after Disaster

Texas Hurricane Center for Innovative Technology (THC-IT)

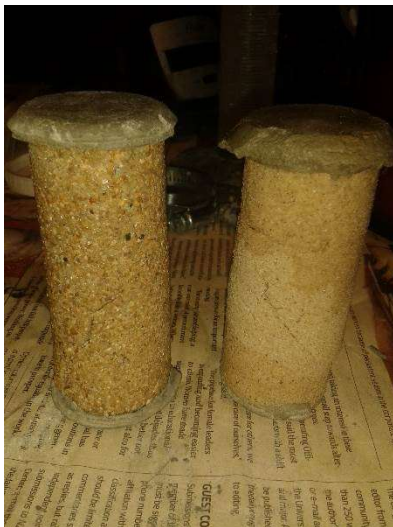
Figure 1. (a) Damaged grouted sands, (b) Repaired grouted sand

In this study, damaged grouted sand were repaired. In the beginning compressive strength of samples were 47 and 45 psi. After disaster, specimens were damaged and the compressive strength was undesirable. The damaged samples were soaked in grout for rapid repair. Repairing resulted in 5% weight gain in the specimens.
