# **Interface Damage Sensing and Repair of Nonmetallic Reinforced Cement Composites Using Smart Coating**

A. El-Hassani and C. Vipulanandan, Ph.D., P.E.

Texas Hurricane Center for Innovative Technology (THC-IT)

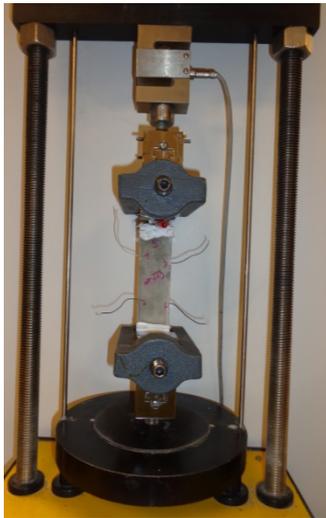
Figure 1. Tensile test setup

In this study, class-H cement was used to produce the paste using 0.3 water-to-cement ratio. The anchors are made of insulator polymer concrete-based material. The polyester resin was used by content of 25 % by weight of sand. Cobalt naphthenate (0.2 wt. % of resin) was added as promoter and methyl ethyl ketone peroxide (2 wt. % of resin) was used as initiator. Rectangular specimens (1.5 in x 1.5 in x 4.0 in) equipped with contact wires embedded into the prepared molds. The nonmetallic reinforcement strand was set adequately in the mold before pouring of the coating cement. Two repair materials were investigated. Smart class-H cement slurry was prepared using 0.7 water-to-cement ratio with added conductive filler (0.03 wt. % of cement). Secondly, repairing material using polyester-based coating was applied. The reinforced composite specimen was tested up to partial damage under tensile loading of the embedded strand. Therefore, the repairing materials were used separately to heal the damaged area then additional pullout tests were carried out to assess the repair efficiency and the interface strength recovery of the reinforced cement composite.

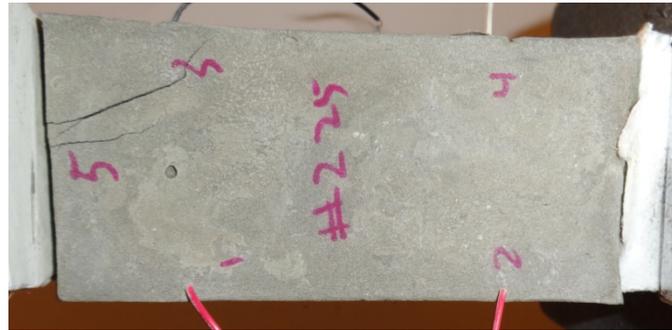
Figure 2. local damage initiated at the interface

The interface damage started at 1.8 ksi of stressing level. The formation of the related crack continued up to local ultimate damage at 3.7 ksi. Repairing the crack by injection of smart cement showed a recovery of 40% of the original strength. However, the repair using smart polyester-based material increased the recovery up to 80%. The impedance spectroscopy method was sensitive to detect the initiation debonding as observed in figure (4).
