Methodology for Rapid Repair of Damaged Pipeline after the Disaster

Navid Salehi Najafabadi and C. Vipulanandan PhD, P.E.

Texas Hurricane Center for Innovative Technology (THC-IT)

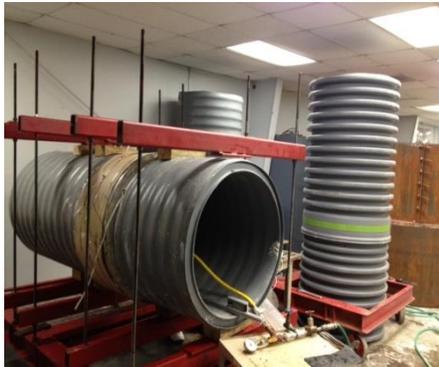
Figure 1. Repair of joint

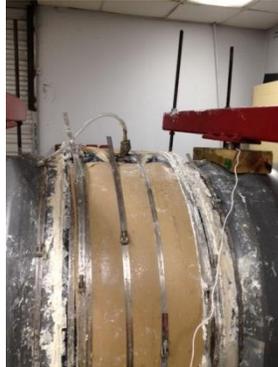
Figure 2. bladder

3.2) Building the FRP Bladder: After the cleaning the, two strips of rubber with the thickness of ranging (7.5-15 mm) will be wrapped and stuck around the pipe on each side of the leak or cracked zone. Now on the top surface of the installed rubber epoxy glue should be applied and a wide strap of UV curing FRP will rest from one strap and continues laterally to the top of the other strap. The final configuration will be like a beam on two supports that the FRP sheet is the beam and the support are those two rubber strap. The final shape will be like (Figs.1 and 2) which is like a bladder that there is empty space trapped between the FRP sheet and pipe exterior surface. After that a small injection hole will drilled on the and a small valve is installed on the hole.

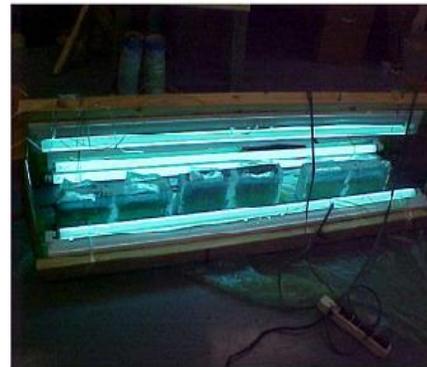
Figure 3. Closer view of grout

3.3) UV Curing: Now it is time to arrange the UV lamps around the pipe on the FRP sheets and the FRP will be cured for I Hour [3]. The configuration of lamps is shown in Fig.3.
